Contract #: 04-0120F4Cty: SF/ALA Rte: 80 PM: 13.2/13.9File #: 69.28**WELDING INSPECTION REPORT****Resident Engineer:**Pursell, Gary**Address:** 333 Burma Road**City:** Oakland, CA 94607**Report No:** WIR-002342**Date Inspected:** 11-May-2008**Project Name:** SAS Superstructure**OSM Arrival Time:** 1400**Prime Contractor:** American Bridge/Fluor Enterprises, a JV**OSM Departure Time:** 2300**Contractor:** Zhenhua Port Machinery Company, Ltd (ZPMC), Changxing Island **Location:** Shanghai, China

WELDING INSPECTION REPORT

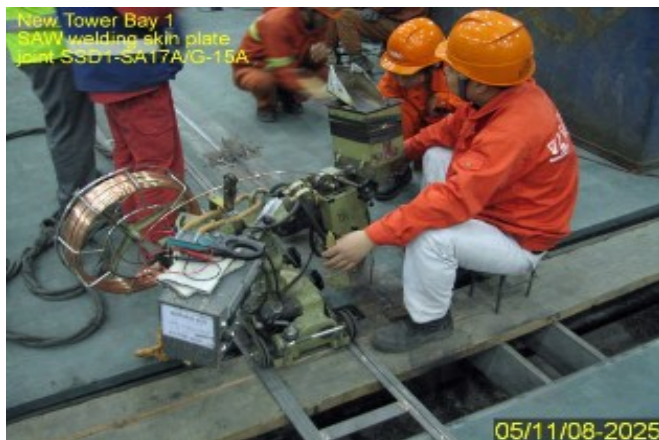
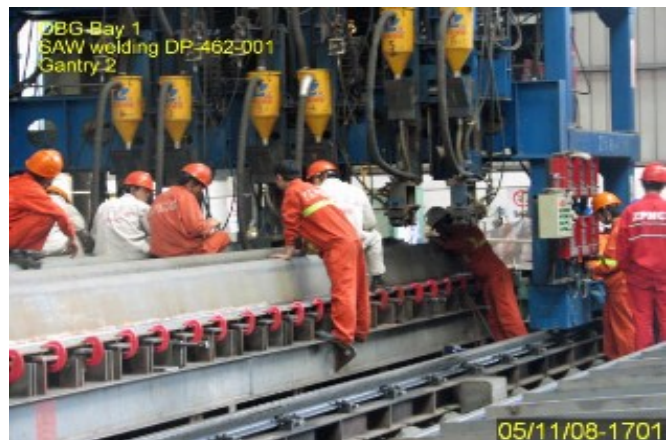
QA performed visual verification inspection for completed Partial Joint Penetration (PJP) U-rib to deck plate welds on deck panel DP-248-001 weld W1. All welds that were inspected appeared to exhibit some degree of undercut, lack of fusion, overlap, oversize and/or under fill. All of the completed (PJP) welds joining U-Rib to deck plate that have inspected on this panel do not appear to comply with the visual acceptance criteria specified in AWS D1.5 2002 and the contract documents. QA completed a Caltrans QA visual verification weld inspection report concerning only the welds that were verified for the OBG deck panel mentioned above. The report is on file in the Caltrans QA office.
